New Drive Chain and Seal for Intermediate Shaft

Vehicle Type: **Boxster / Boxster S**

Model Year: **As of 1997 (V)**

Concern: **Drive chain and seal for intermediate shaft modified.**

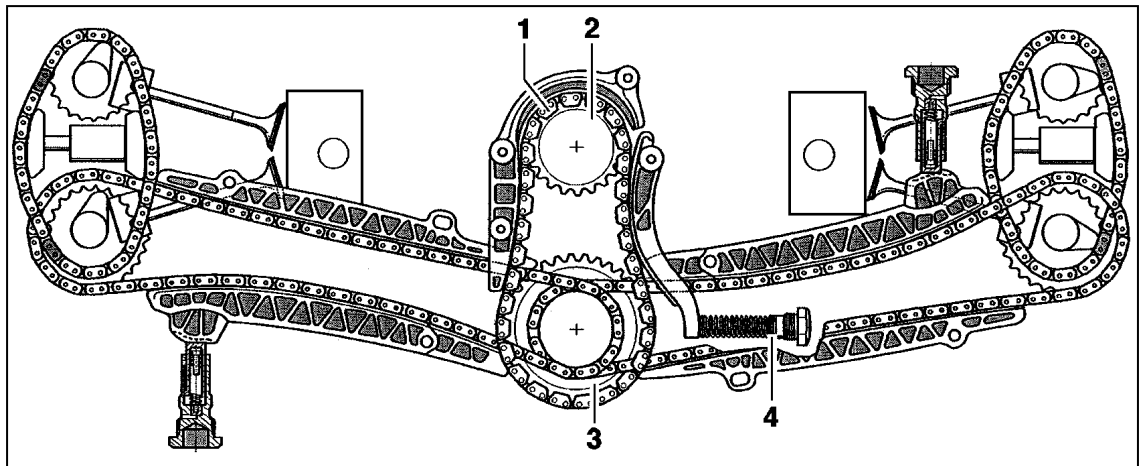
Repair: **Camshaft drive:**

Information: To reduce engine noise, the drive chain for the intermediate shaft (primary drive) has been changed from a roller-type chain to a tooth-type chain (figure 1). The changes were introduced into production on August 15th, 2000, as of engine numbers:

The following parts have been changed because of the conversion to the tooth-type chain for intermediate shaft drive:

- 1** - Drive chain for intermediate shaft
- 2** - Crankshaft
- 3** - Intermediate shaft
- 4** - Chain tensioner

Note: Roller-type chains remain in use for driving the camshafts.

Repair: After existing supplies of the previous parts have been used up, the new parts can be used as replacements for all Boxster engine types M96.20, M 96.22, and M96.21.

A mixed configuration is not permissible, as the parts are matched with each other. The previous chain tensioner, part No. 996 105 180 54, is still available and may continue to be used on engines that have the previous style drive chain installed.

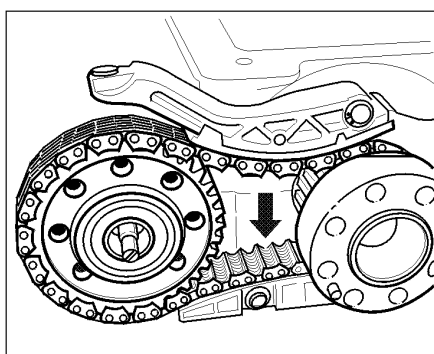
Figure 2, Tooth Type Chain

New Version

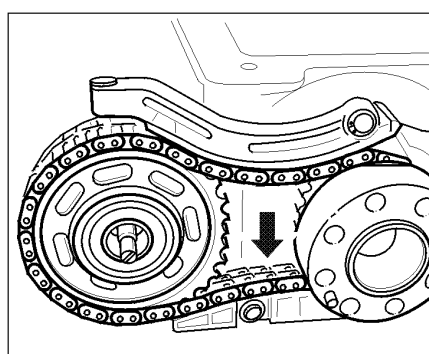
**Figure 3, Roller Type Chain
No Longer Available**

Previous Version

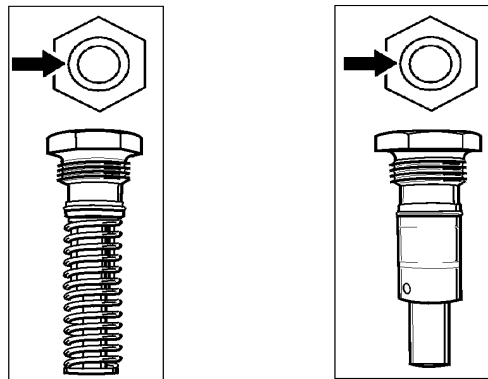
Repair: The marking on the head of the chain tensioner is unchanged (1-ring, arrow).

New intermediate shaft seal.

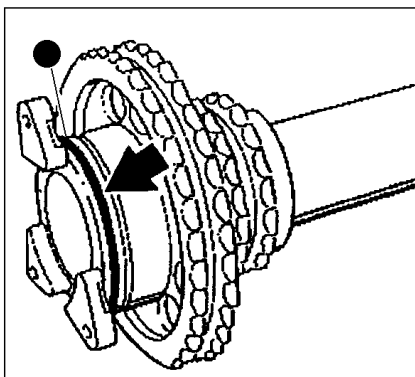
Figure 8, Previous Version Seal

The sealing ring on the bearing flange for the intermediate shaft has been changed from an O-ring (figure 8) to a 4 mm wide sealing ring with three sealing lips (figure 9). The changes were introduced into production on September 12th, 2000, as of engine numbers:

The new intermediate shaft-bearing flange with rectangular sealing ring is available for repairs on all engines (1997 to present) with a roller-type or tooth-type chain. The new bearing flange (part number, 996 105 017 01) is available only with the sealing ring fitted. The sealing ring cannot be replaced individually. The previous bearing flange with O-ring must no longer be installed.

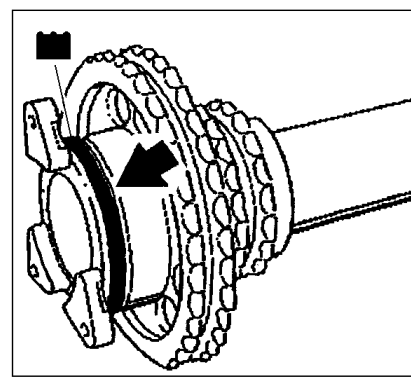
Figure 9, New Version Seal

There is a wider groove in the intermediate shaft to accommodate the new sealing ring. The new sealing ring is rectangular (previously: O-ring) and approx. 4 mm wide on the sealing surface (arrow, figure 9).

The new sealing ring is an integral part of the bearing flange and cannot be individually replaced.
